# Inspection Report

Address: **123 Anystreet, Anytown**  
Report Number: 11515\_20170515103023  
Date: 05/01/2017  
Client(s): John and Jane Doe

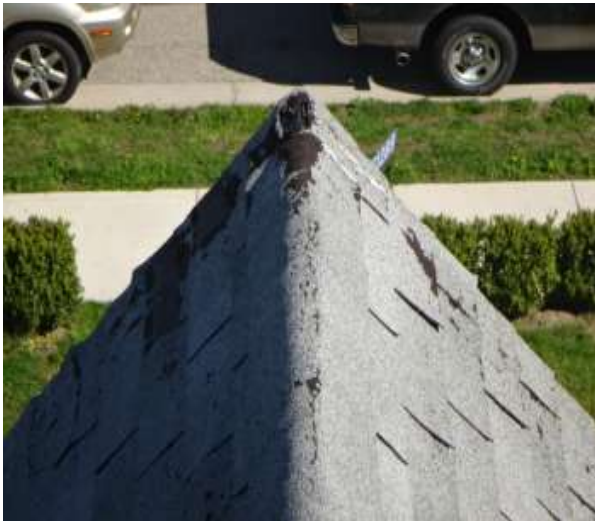
front

### **Finding:** Shingles - Near End of Life

Implication:	Leakage
Location:	Main roof
Action:	Replace
Estimated Timeframe:	1-3 years
Estimated Cost:	\$5,000 to \$9,000

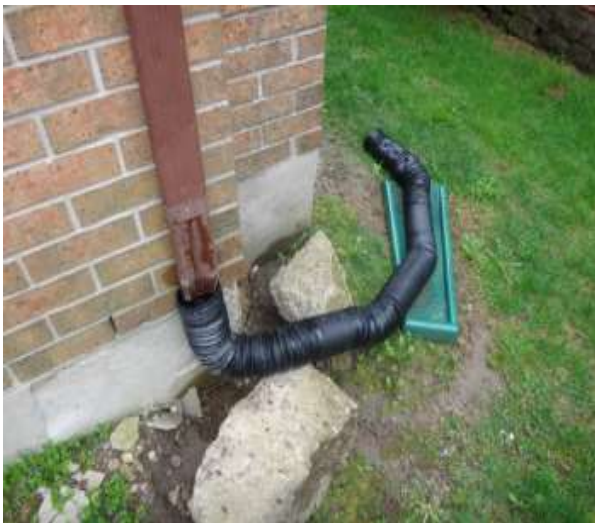
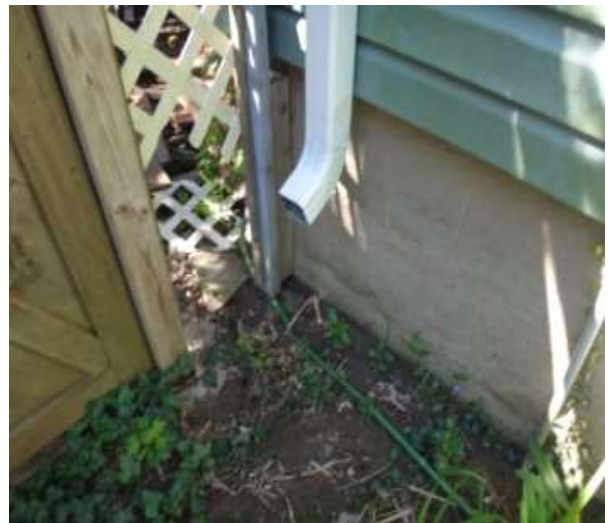
### **Downspouts - Too Close to House**

Greater chance of basement leakage

Several

Improve

At least 6 feet from house recommended, and further if possible.

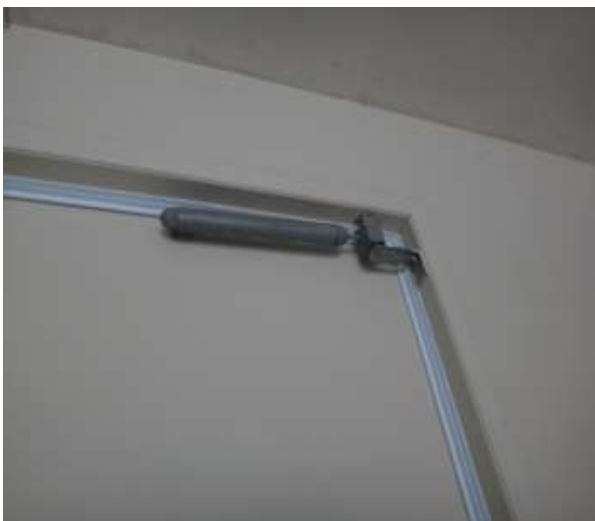
### **Garage - Self Closer Damaged**

Exhaust Fume Entry

Repair or Replace

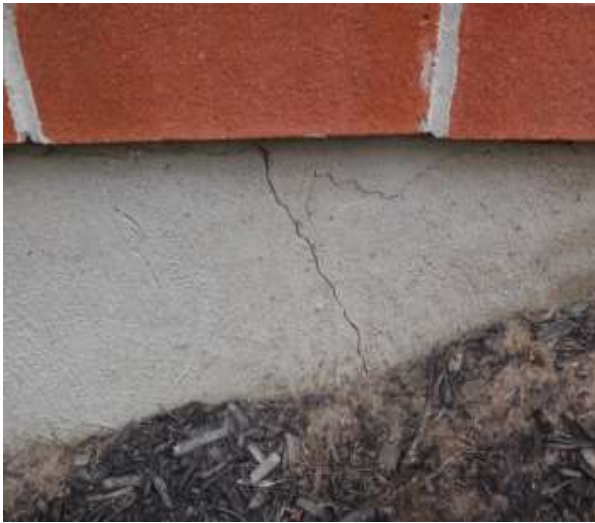
**Foundation - Cracked - Typical, Minor**

Water leakage

Right side

No action needed

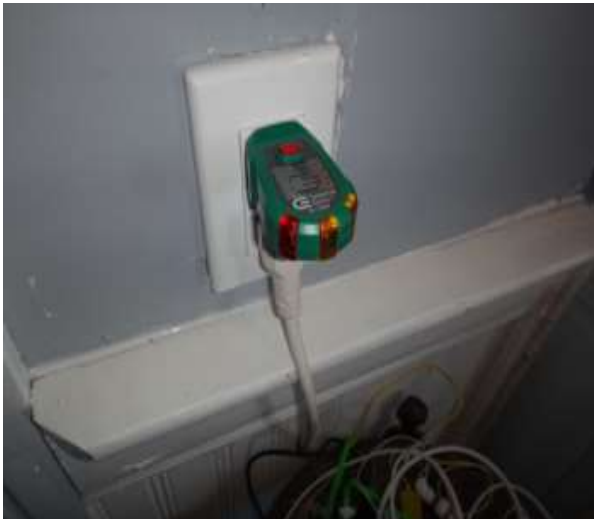
### **Outlets - Hot and neutral wires reversed**

Risk of shock

Kitchen

Repair

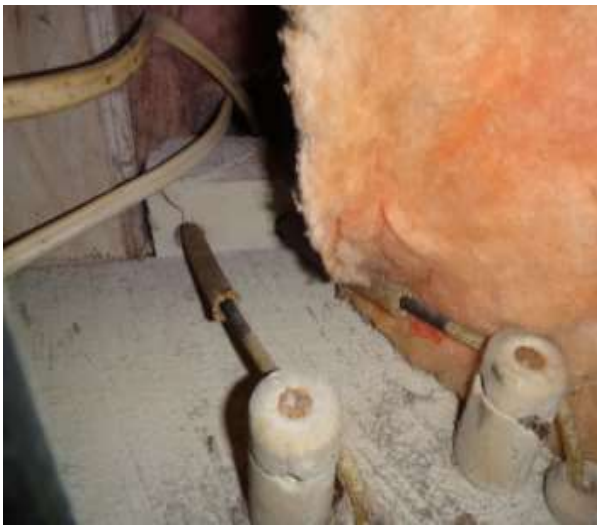
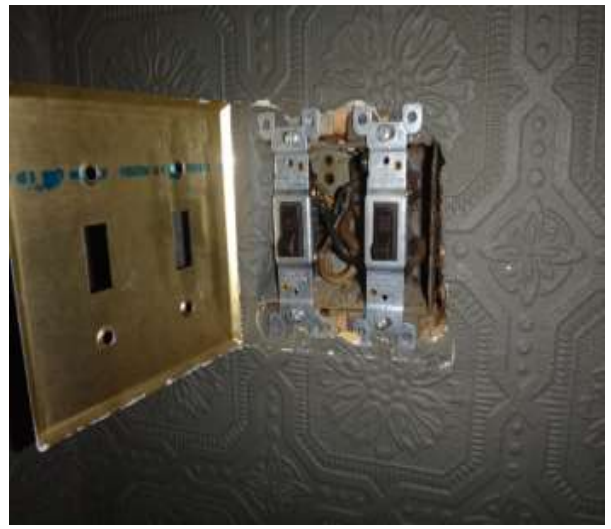
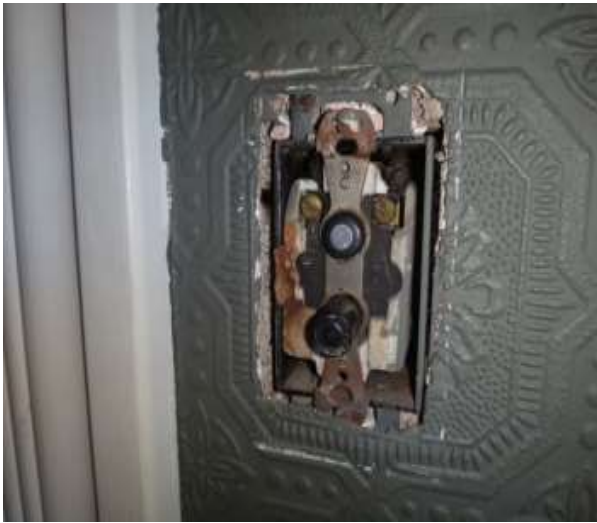
### **Knob and Tube Wiring - Present**

Insurance Issue

Knob and tube wiring was found at the following locations: basement, front porch and dining room lights. Some insurance companies require replacement or inspection of this wiring - please determine your insurance company's policy. Replacement is typically in the range of \$500-\$1,000 per room/area. In this case \$1,500-\$3,000.

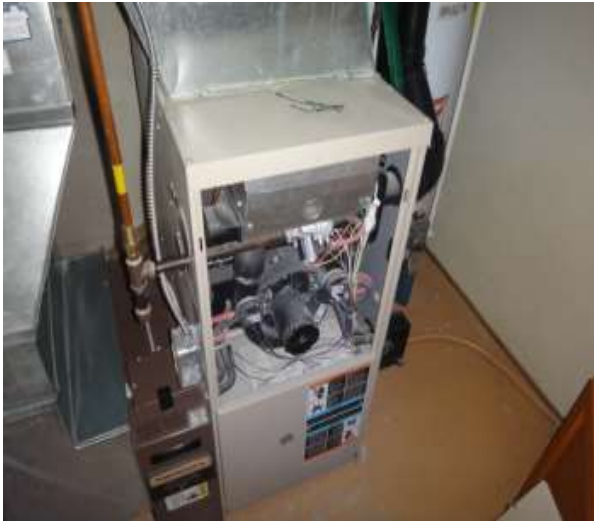
### **Furnace - Near End of Life**

High replacement cost

Furnace typically lasts 15-20 years and this system is within this range at 17 years old.

Replace

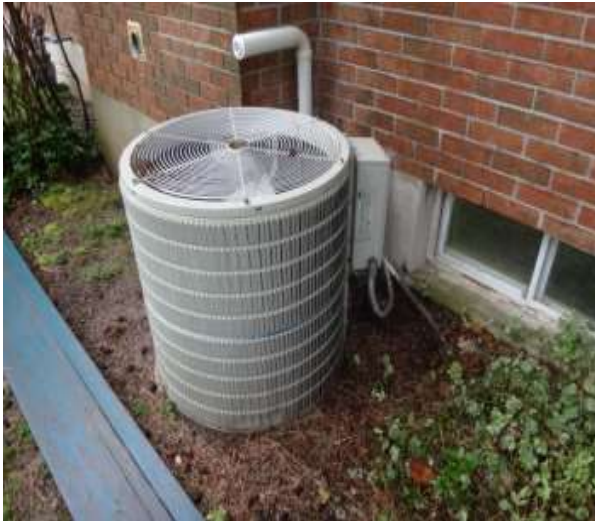
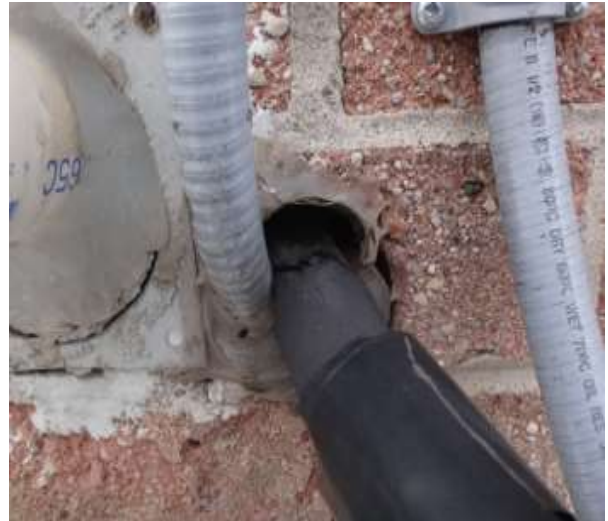
### Refrigerant Pipes - Poorly Sealed at Wall

Improve

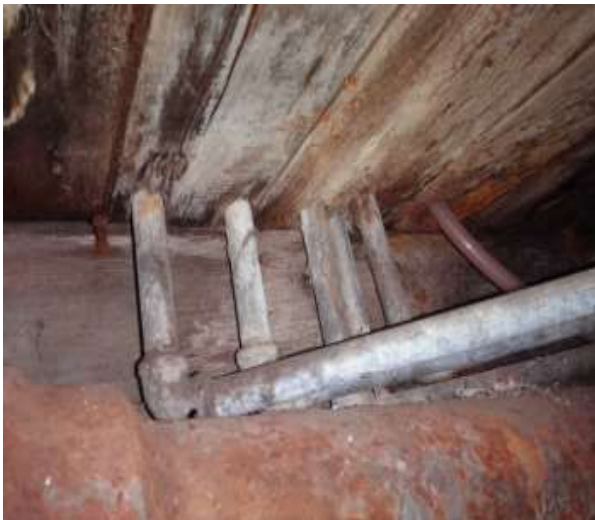
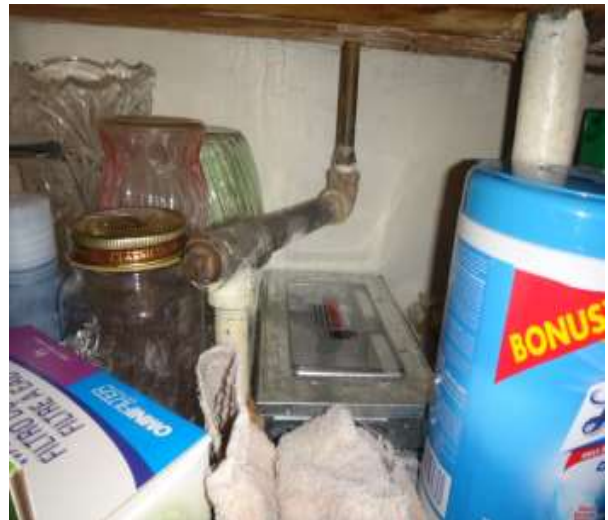
### Water supply pipes - Galvanized steel

Insurance issue

Basement up to bathroom

Replace

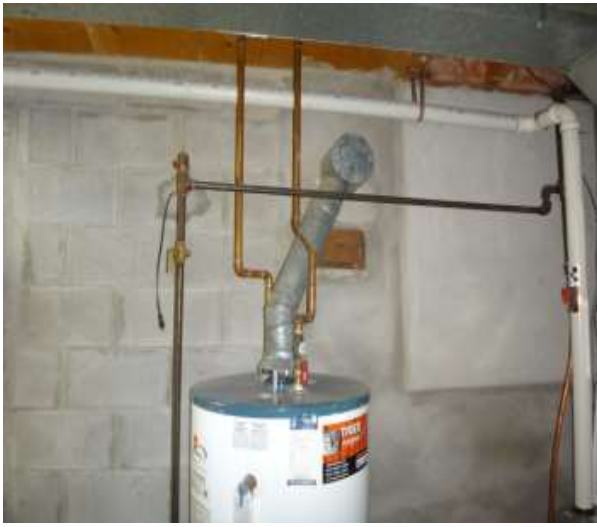
### Water Heater - No Tempering Valve

Scalding hazard

Newer water heaters should have a tempering (mixing) valve which limits the temperature of water delivered to faucets.

Provide

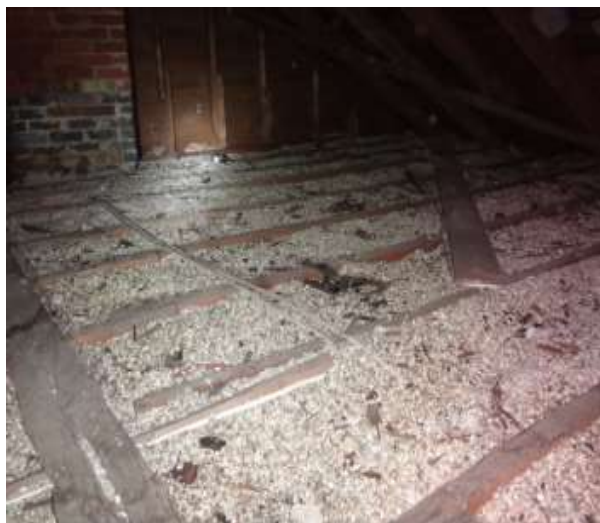
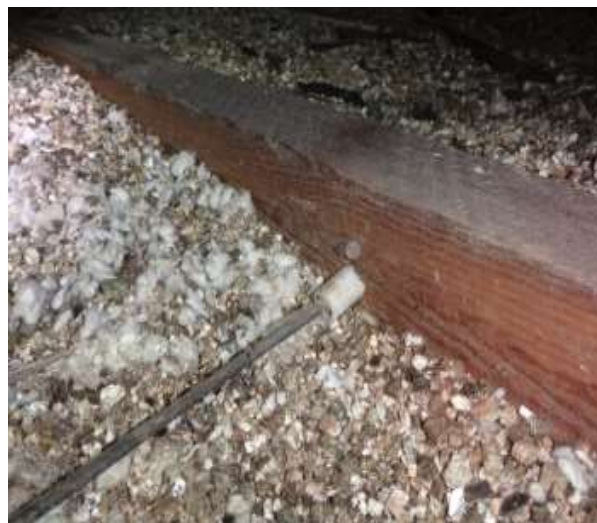
### Attic Insulation - Vermiculite present

Potential Health Concern

Potentially significant

Vermiculite may contain asbestos. A lab test is recommended immediately.

Removal can be in the \$10+/-square foot range.

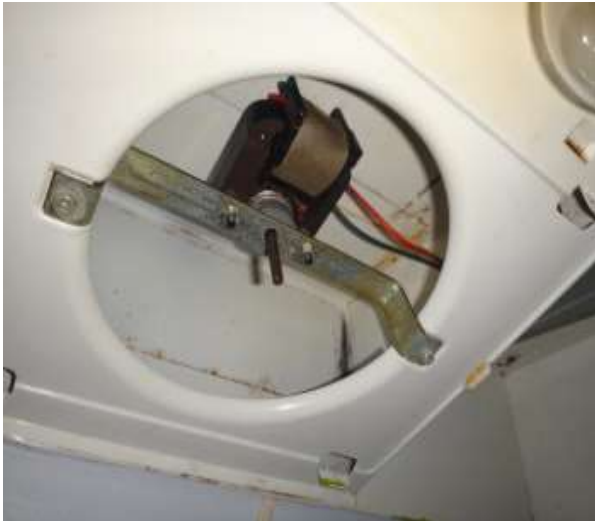
### **Kitchen Exhaust - Inoperative**

Excess moisture/odour inside

There is no fan inside the range hood. Note also that the hood does not vent to the exterior.

Replace

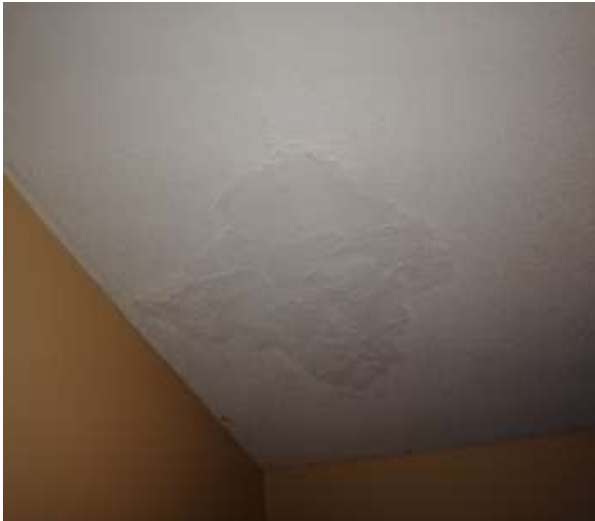
### **Ceiling - Patched**

Below bathroom

No high moisture levels noted at time of inspection.

Monitor

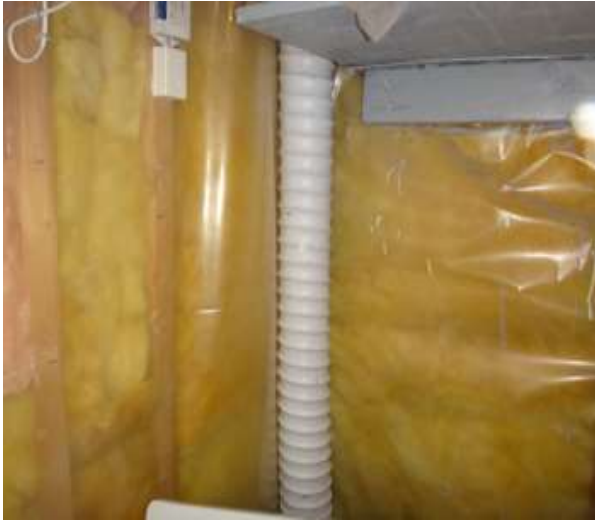
**Dryer - Exhaust Duct Not Metal**

Fire Hazard

Replace

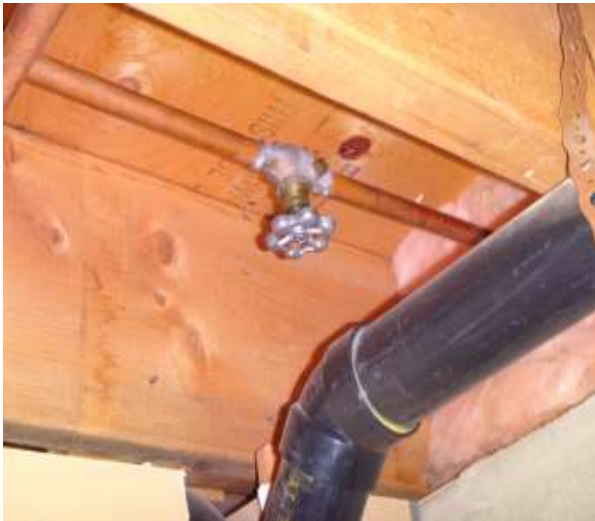
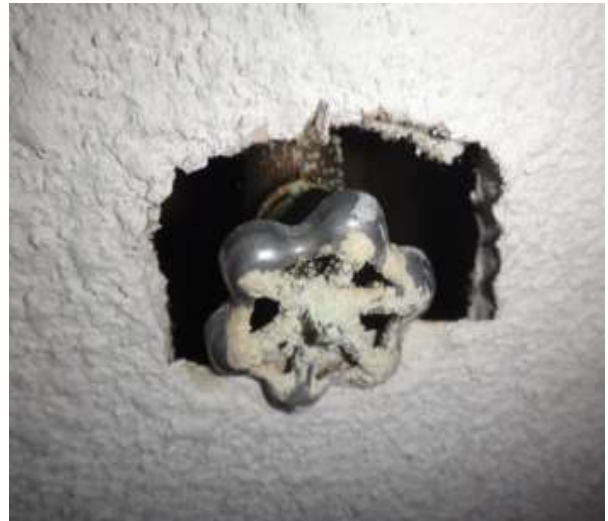
### **Maintenance - Outdoor Taps**

Water control

All outdoor taps (including the one in the garage) should to be "winterized" in late fall to avoid water freezing inside them and causing a split pipe. This is normally achieved by turning off the indoor water shutoff valve, opening the outdoor tap, and then using the drain valve to ensure the water has drained out of the outer portion of the tap and piping.
